Chimney Fires: Causes, Effects & Evaluation

Chimney Safety Institute of America

Chimney Fire Education and Research Task Force

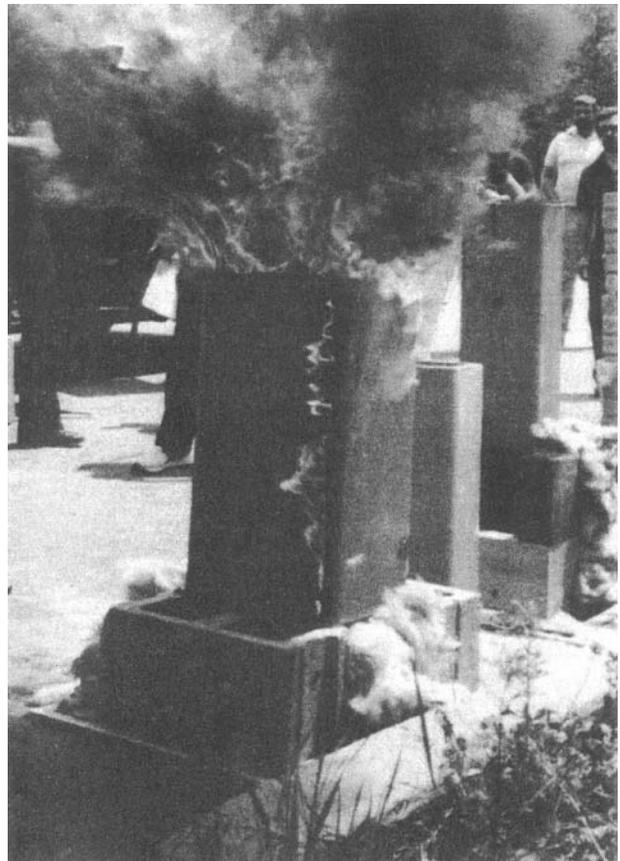
Figure 3-9. In this photograph of a demonstration chimney fire, a clay flue liner, its interior coated with tar, has been ignited to simulate a chimney fire. Notice the severe crack at the near corner and the flame escaping the confines of the liner.

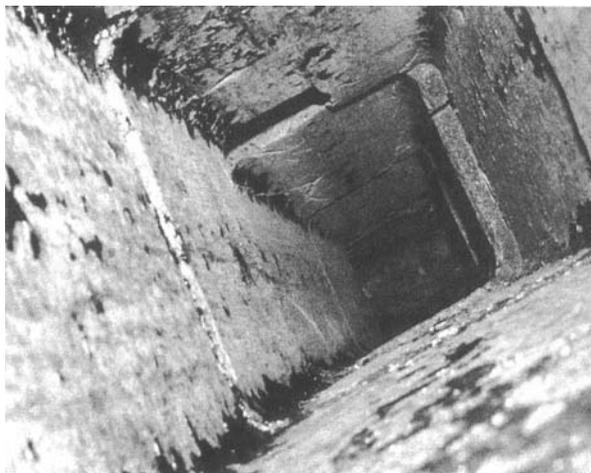
Figure 4-1. The interior of a clay flue tile-lined chimney illustrates the impact of a chimney fire – multiple cracks in tile liner sections and a missing segment of tile which fell down into the smoke chamber/damper area.
